INVESTIGATION OF THE NORTHWEST AREA OF
ROCKY MOUNTAIN ARSENAL

GEOHYDROLOGY DIVISION
CONTAMINATION CONTROL DIRECTORATE

NOV 78

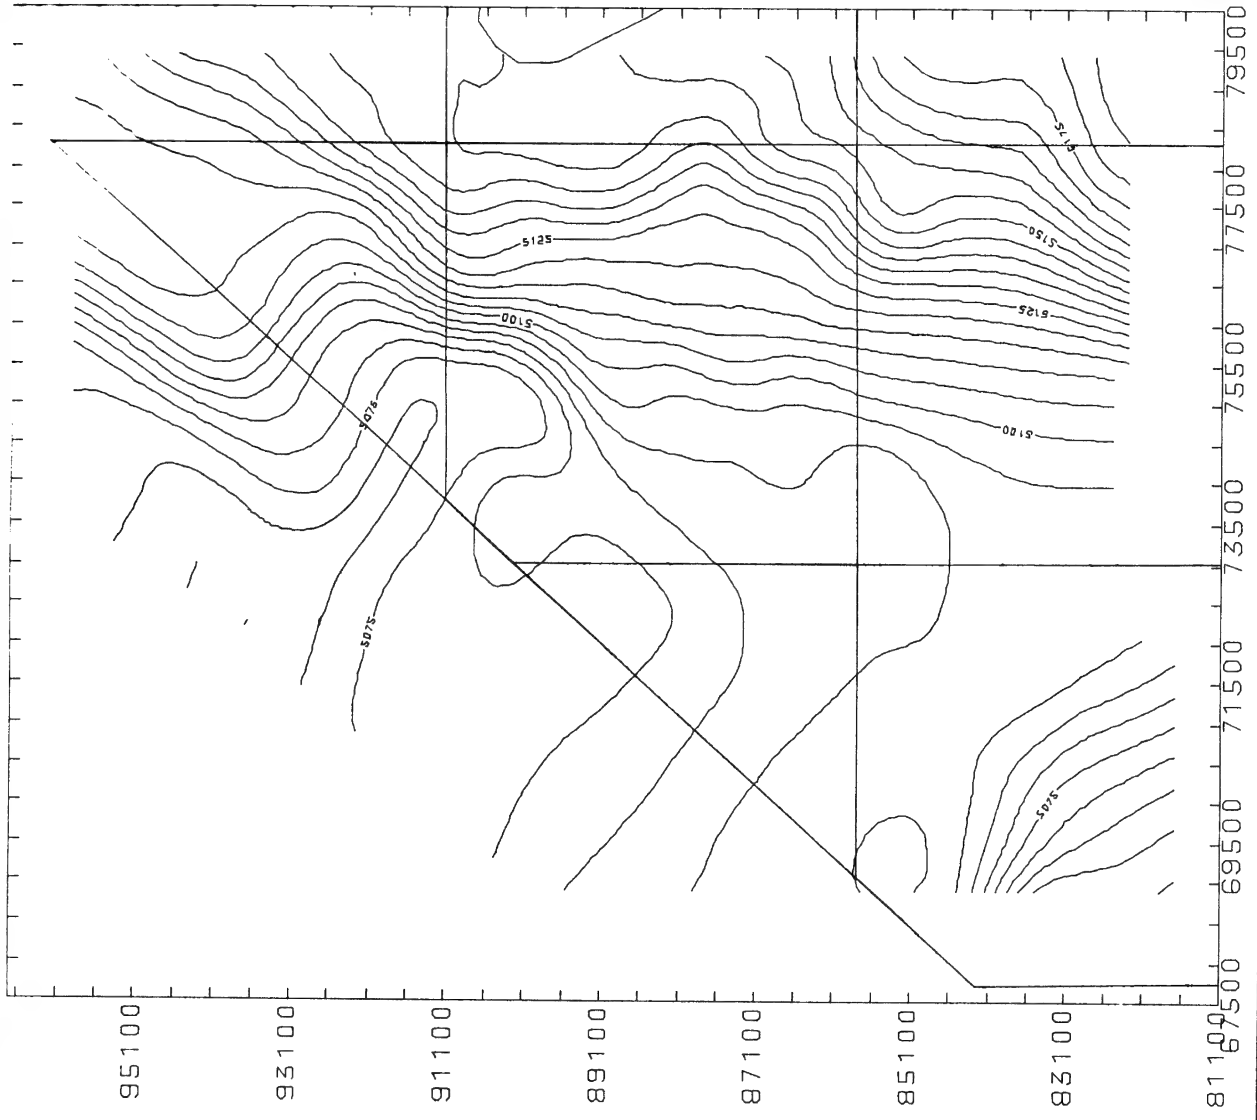
(7) The field drilling operation identified the bedrock contact at 257 locations in the study area. From this data, both a bedrock contour map and transect map were constructed (Figures 5 and 6). The bedrock contours indicate that the Denver-Arapahoe unit slopes generally from southeast to northwest. In detail, the bedrock surface is irregular with numerous channels and gullies apparent. The study area overlies two major channels. The channel which has the most influence in the hydrology of the study area lies on the eastern edge of Sections 34, 27, and 22. The second channel is located on the southwestern

corner of the study area. Both channels are characterized by the close contour intervals on the bedrock contour map, Figure 5. The small irregularities of the bedrock surface are very likely due to the erosional characteristic of the material. The erosional forces moved the sand and silty sand bedrock materials easier than the clay and silty clay materials. With the formation of interbedded layers of these materials, the potential for an irregular erosional surface to be developed exists. The patterns of the erosional forces are also responsible for the irregular bedrock surface

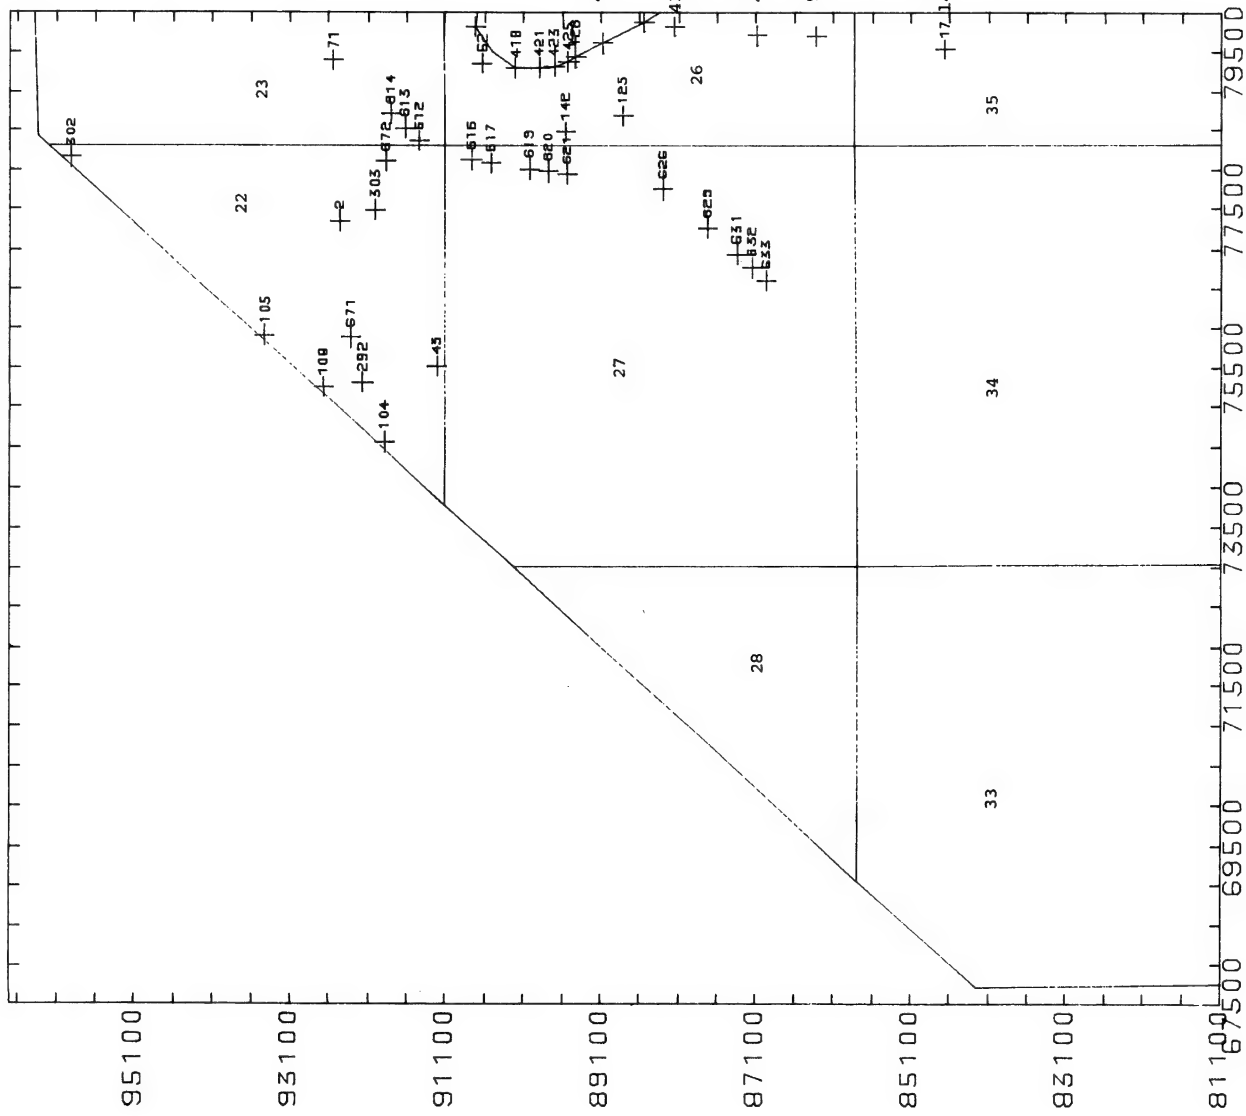
FIGURE 31. LOCATION OF WELLS IN THE
NORTHWEST AREA OF RMA CONTAINING
SIGNIFICANT LEVELS OF FLUORIDE
SCALE: As shown

(4) High fluoride levels were observed throughout the study area (Table 4, Figures 31 and 32). High concentrations were detected in wells adjacent to the Arsenal boundary in Section 22. The quantity of water moving off post in the portion of the area having significant water flow was calculated using the

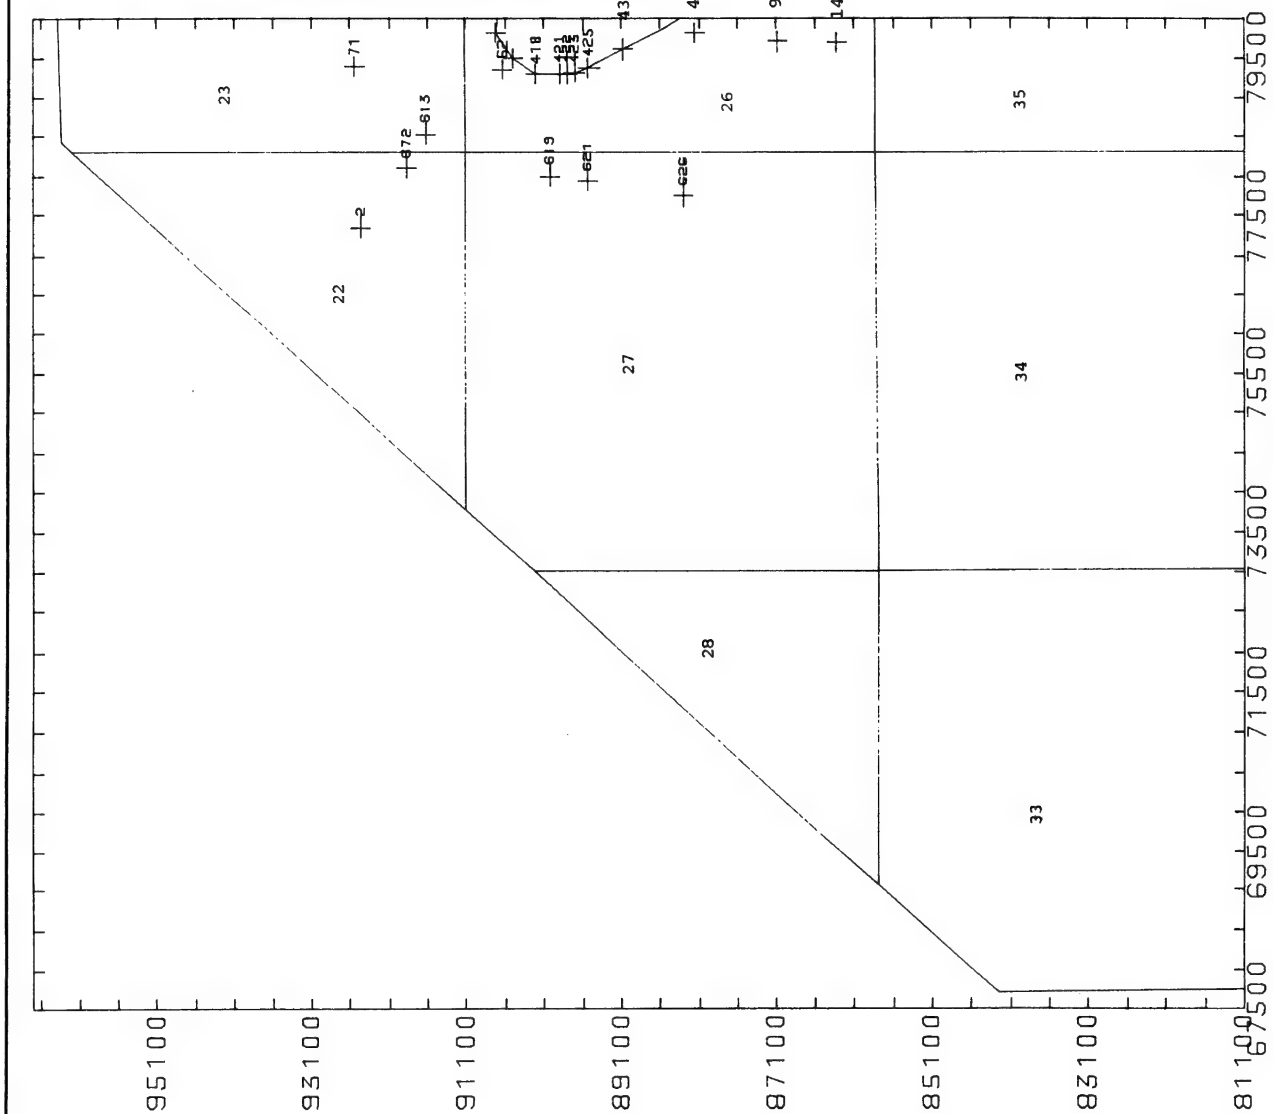
FIGURE 33. LOCATION OF WELLS IN THE
NORTHWEST AREA OF RMA CONTAINING
SIGNIFICANT LEVELS OF DIMP.

(5) High DIMP levels were detected at the edge of Basin F and in an area extending northwest from the northwest corner of that Basin (Table 4, Figures 33 and 34). Few high DIMP values were observed along the E-E' line. Well 27-23 had the highest value, but this sample was recovered from a hole drilled deeply into bedrock. This may be an accurate value or result from a concentration artifact as seepage into the hole evaporates. This well can only be sampled when long-time periods pass between sampling efforts to allow water build up. DIMP was observed along the northwest boundary, but at only extremely low levels.

c. High DIMP levels were observed along the edge of Basin F or in an area extending northwest of the northwest corner of the Basin. The question is whether DIMP is advancing. The area of concern does not reach the Arsenal boundary. A review of the Jun 77 USGS publication, "Digital-Model Study of Groundwater Contamination by DIMP, RMA, near Denver, Colorado - Final Report" indicates that concentrations above 200 ppb should not be observed in that portion of the study area, based upon the assumption that no additional DIMP input occurred beside the original source. The Report concluded that high DIMP levels observed in the northwest resulted from a secondary source. The Report indicated that insufficient information prevented identification of the mechanism or source(s) for this contamination. Possibilities were:

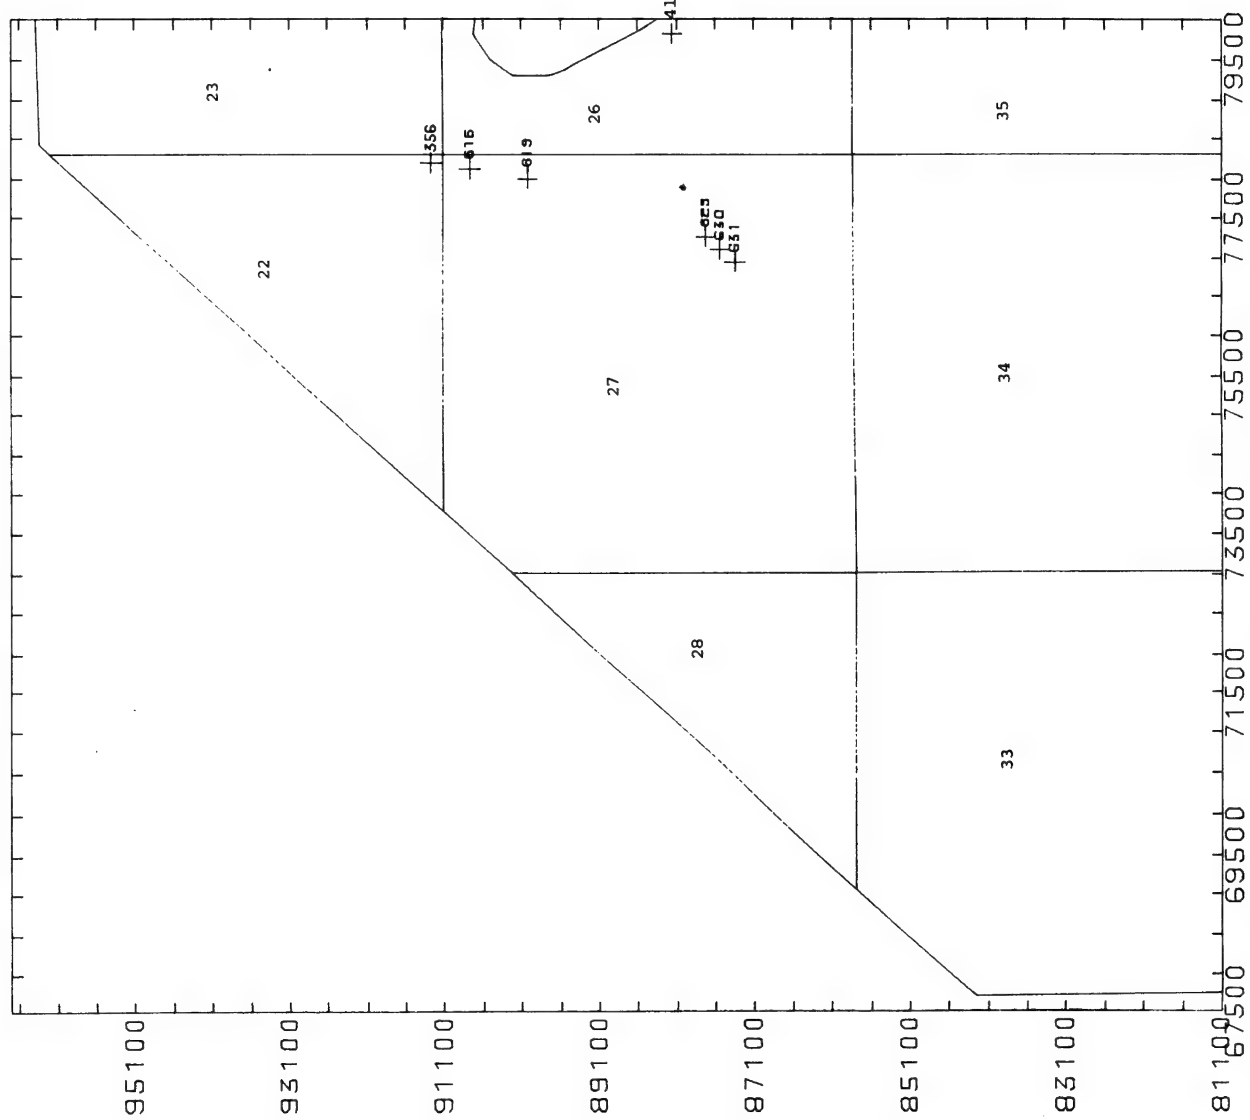
FIGURE 35. LOCATION OF WELLS IN THE NORTHWEST AREA OF RMA IN WHICH DCPD WAS DETECTED.

(6) DCPD was very rarely observed (Table 4 and Figure 35), essentially only along the E-E' line. It was also normally only observed on the first analysis. Most of the positive results were obtained when the standard was later determined to be defective. DCPD, however, was detected when the standards were correct. The most recent sampling was negative.

d. The status of DCPD cannot be resolved without careful further sampling. Initial sampling was normally the only sample in which the substance was detected, and the standards were later discovered to be faulty. In some instances, however, DCPD was observed in a second analyais; and the standards were correct. Other subsequent analyses were negative. Which effort is correct?
